AFRL-ML-WP-TR-2004-4237

**RESEARCH ON ADVANCED
NONDESTRUCTIVE EVALUATION
(NDE) METHODS FOR AEROSPACE
STRUCTURES**

**University of Dayton Research Institute
300 College Park
Dayton, OH 45469-0120**

Final Report for 30 September 1998 – 31 December 2003

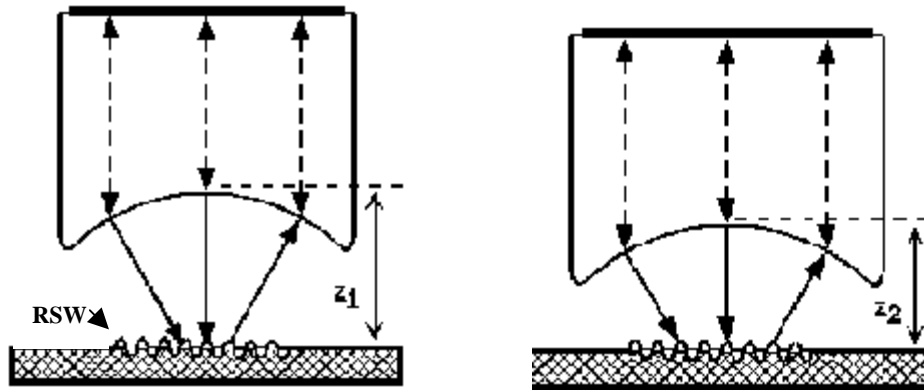
Figure 3.1.3-1. Transducer defocused 0.4 mm at Z_1 (left) and 1.0 mm at Z_2 (right).

Z_1 and Z_2 are the two defoci. Δt_1 and Δt_2 are the times measured from a reference position to the direct-reflected signal at two defoci. $\Delta t_{\text{saW}1}$ and $\Delta t_{\text{saW}2}$ are the time from the same reference to the SAW signal at the two defoci (Figure 3.1.3-2). This is the time difference method of SAW velocity measurement.

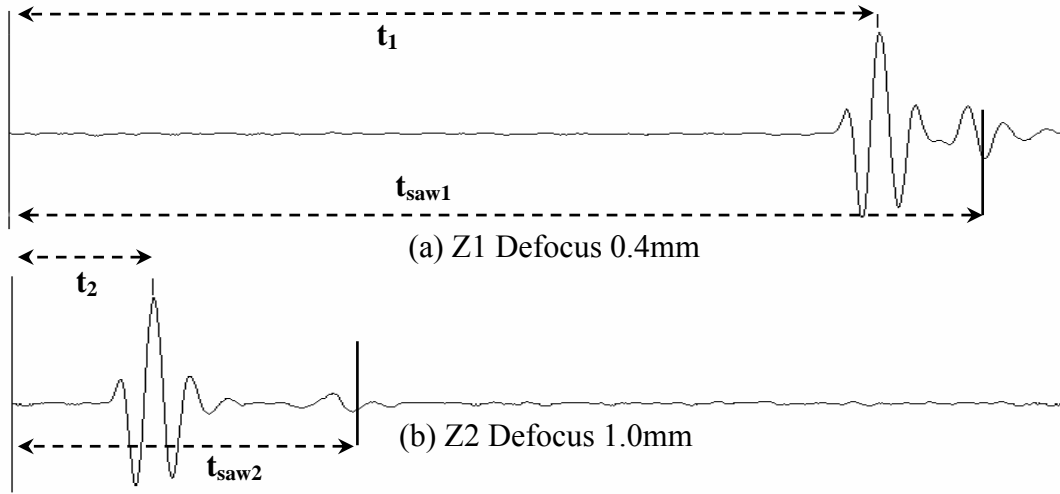
Figure 3.1.3-2. Waveforms of the direct-reflected and SAW signals at two different defocus positions.

In practice, the arrival times (Δt_1 and Δt_{saw1}) at defocus positions Z1 and Z2 are calculated and the velocity is determined from equation 1. Then, the arrival-time measurements and velocity calculations are repeated several times at the two defocus positions and the results are averaged to provide a single velocity value at the data-acquisition point. The acoustic lens is moved to a new position and the measurements are repeated. The entire procedure is repeated at periodic locations on the sample to generate an image of SAW velocities (or elastic properties).

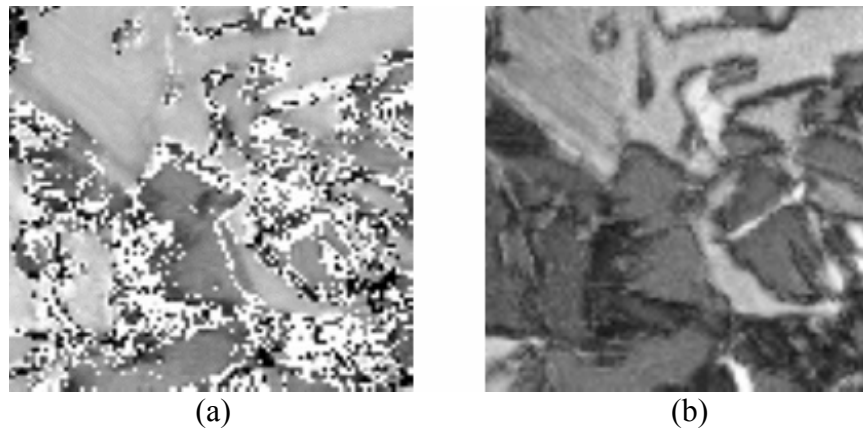
Figure 3.1.5-1. Rayleigh-surface-wave images of large grains in a Ti-6Al-4V material: (a) velocity and (b) amplitude.

The two-point defocus technique was used to image the microstructure of large-grain-size Ti-6Al-4V. The Rayleigh SAW velocity was measured and mapped over a $15\text{ mm} \times 15\text{ mm}$ area of the sample. The amplitude of the Rayleigh SAW was also used to generate a C-scan map of the sample's surface. The amplitude and the velocity images are provided in Figure 3.1.5-1.

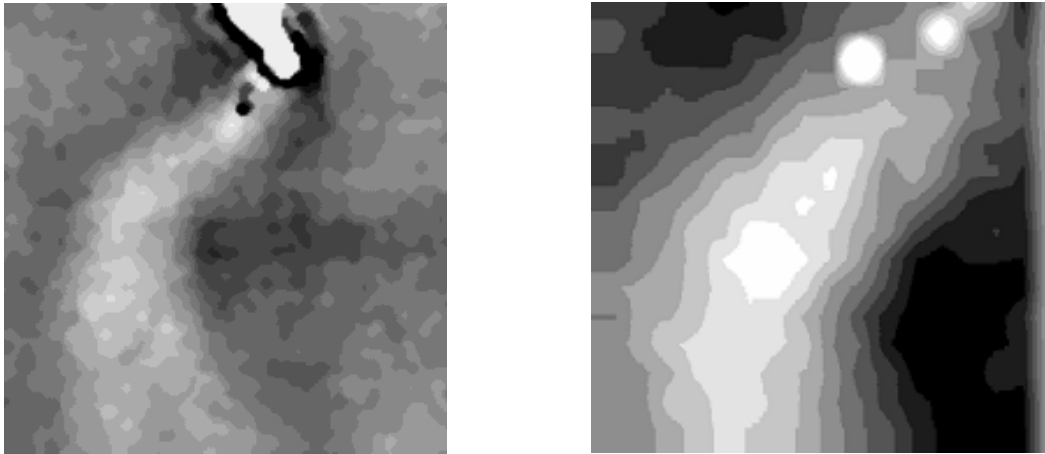
Figure 3.1.5-2. Images of stress around a crack tip in Ti-6Al-4V: (a) SSLW velocity measurements of stress and (b) x-ray diffraction measurements of stress.

X-ray diffraction measurements of very-near surface stress were also made at a large number of locations near the same crack tip and an image was constructed from these measurements. The images constructed from these x-ray diffraction measurements are provided in Figure 3.1.5-2b. The visual similarity of the image constructed from the SSLW measurements and the image constructed from the x-ray diffraction measurements is striking.

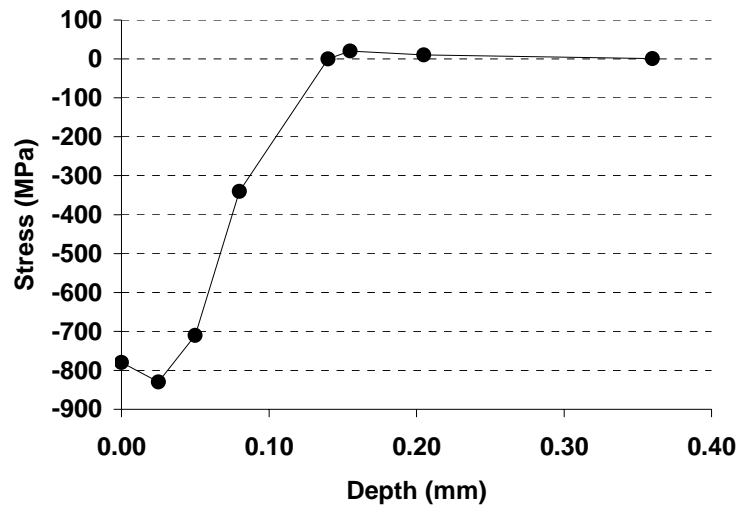
Figure 3.2.1-1. Typical stress versus depth curve for shot-peened titanium-alloy specimen.

material is shown in Figure 3.2.1-1. Air Force engineers need a nondestructive technique for measuring that profile so that they can accurately estimate the remaining fatigue life of specific components. Thus, UDRI initiated a project to develop a nondestructive technique for measuring the residual stress gradient as a function of depth in aerospace materials.

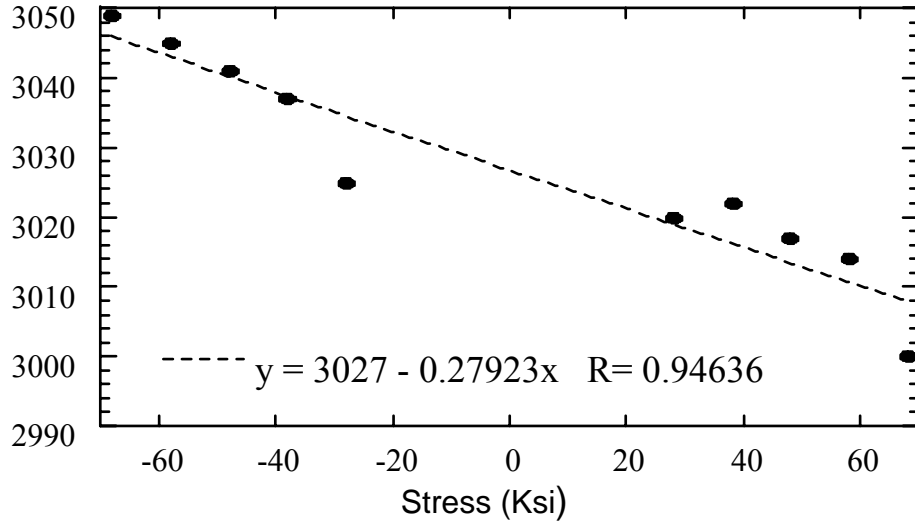
Figure 3.2.3-2. Rayleigh surface wave velocity as a function of stress in Ti-6Al-4V.

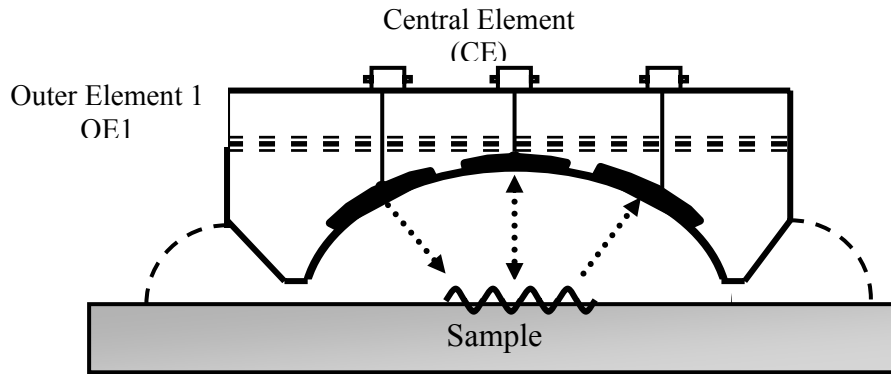
Figure 3.2.4-1. Three-element acoustic microscope transducer.

In equation 2, F is the acoustic frequency, V_R is the Rayleigh wave velocity in the material, ΔV_R is the change in the Rayleigh wave velocity, θ_R is the Rayleigh wave critical angle, and Δz is the defocus distance. The smallest velocity change that can be measured using the phase measurement approach is about 1 part in 10^6 .

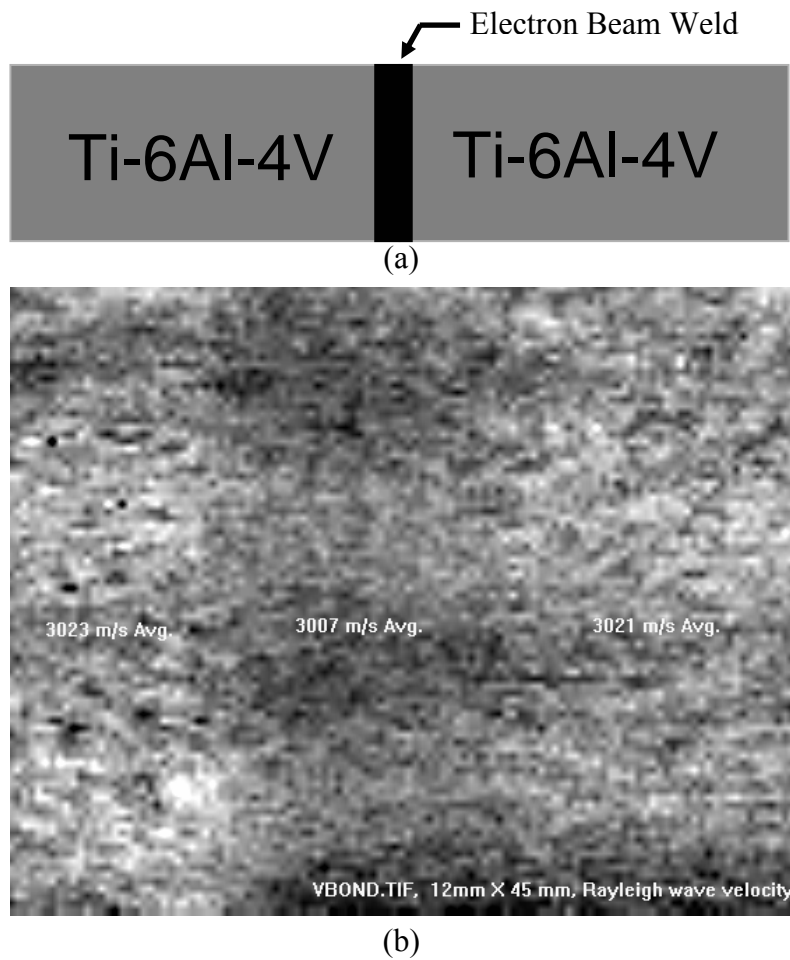
Figure 3.2.4-2. E-beam welded Ti-6Al-4V specimen: (a) sketch of the specimen and (b) velocity map across the weld line using the two-point defocus method.

The applicability of the lens and instrumentation was first tested by measuring the change in the RSW velocity across an electron beam weld line in a Ti-6Al-4V specimen. The weld specimen is depicted in Figure 3.2.4-2a. A velocity image map of the weld specimen using the three-element lens is shown in Figure 3.2.4-2b. Both of the phase-measurement methods were used with the three-element transducer to generate a phase-change profile across weld in the specimen. A stress profile across the specimen was also measured directly with an X-ray diffraction system (XRD). The results of the acoustic-wave phase-difference measurements and the X-ray diffraction measurement are shown in Figure 3.2.4-3. The results clearly show that the RSW velocity is higher (darker color) in the region of compressive residual stress around the weld, while in the region of tensile stress, it is lower (lighter color). The measurement techniques can detect phase changes caused by residual stress variations of the order of 1-2 MPa. This sensitivity is at least an order of magnitude improvement over the earlier two-point defocus method.

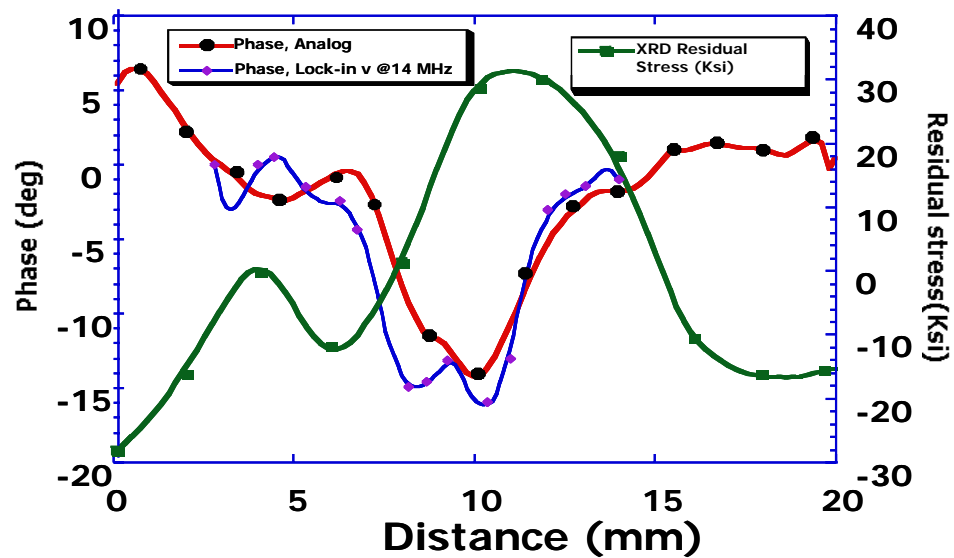
Figure 3.2.4-3. Variation of phase-difference measurements and x-ray diffraction residual stress measurements across a weld line in Ti-6Al-4V.

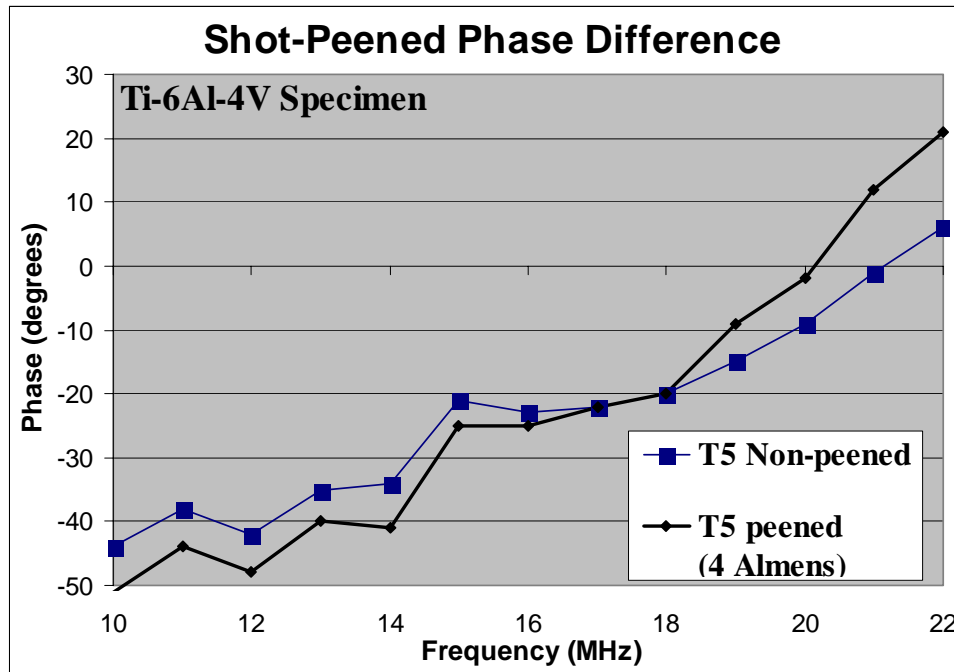
Figure 3.2.4-4. Phase difference data on peened and non-peened Ti-6Al-4V.

The relatively wide-band (10 to 25 MHz), three-element, focused acoustic transducer has been found to be very sensitive to small variations in residual stress. Thus, the quantitative measurements of RSW dispersion in surface-treated aerospace materials should be possible with this three-element transducer. UDRI has made RSW velocity measurements on shot peened material and also on low-plasticity-burnished samples of Ti-6Al-4V. The results are shown in Figures 3.2.4-4 and 3.2.4-5, respectively. The plots in those figures demonstrate that RSW velocity dispersion is present in both samples. The dispersion is independent of the direction of measurement in the case of the shot peened sample, while on the low-plasticity-burnished specimen, the RSW dispersion is dependent on the direction of measurement.

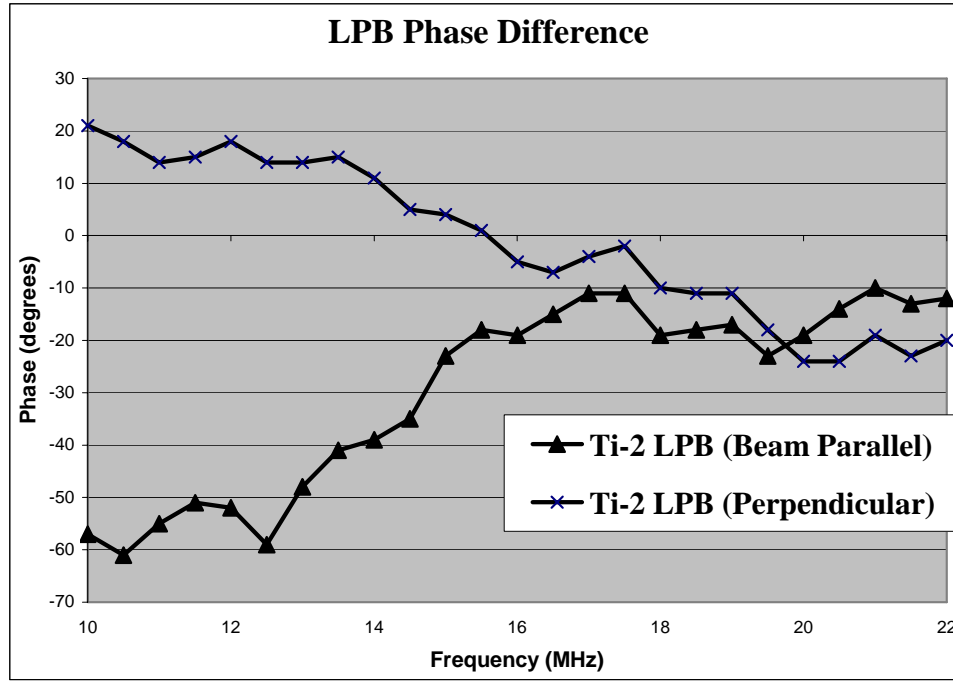
Figure 3.2.4-5. Rayleigh surface wave phase-difference measurements on LPB material.

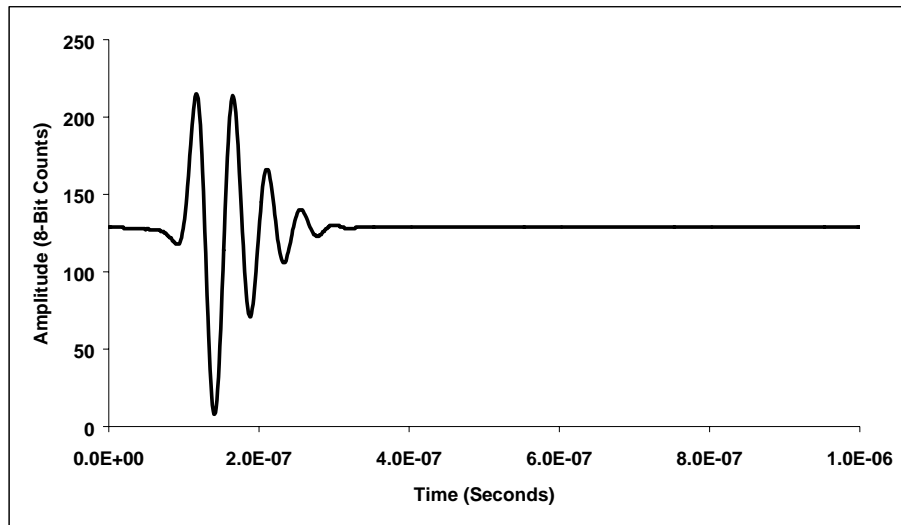
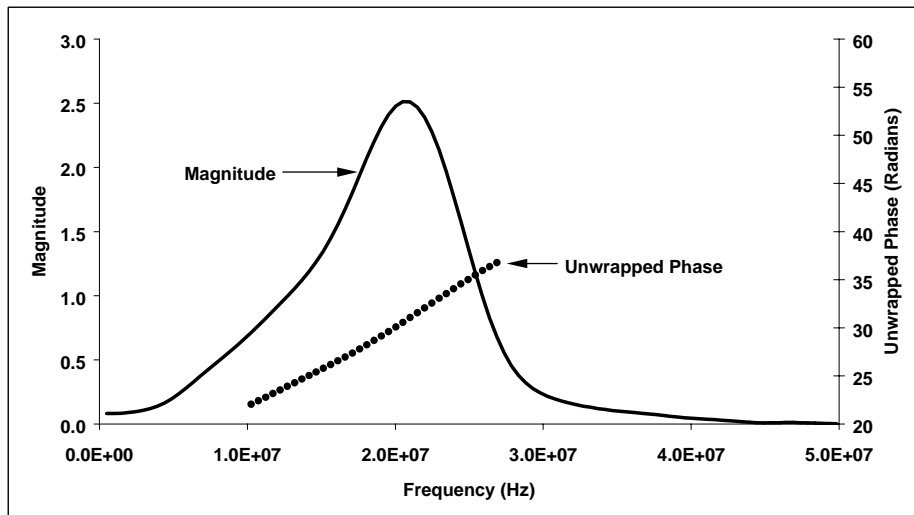
Figure 3.3.2-1. Reference signal: (a) time domain and (b) Fourier Domain

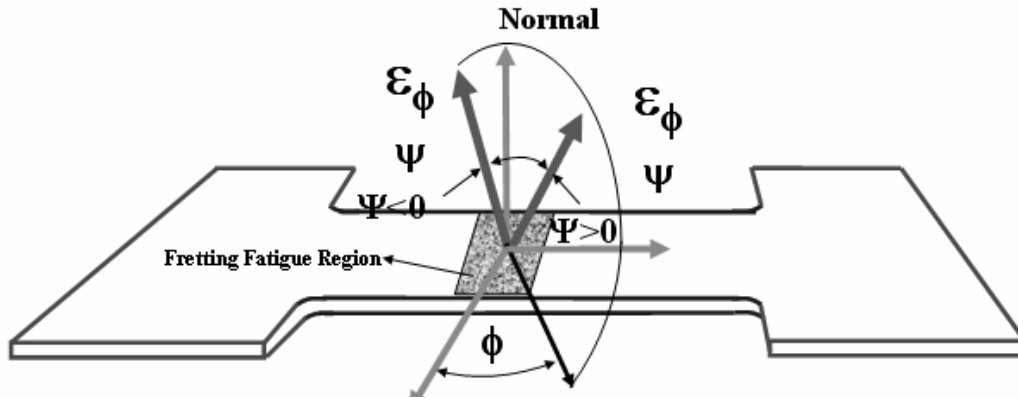
Figure 3.5.3-1. Locations and directions of x-ray diffraction measurements relative to the direction of fretting.

UDRI developed a research project to: (1) gain understanding of the behavior of residual stress under fretting-fatigue conditions, and (2) determine the capabilities of x-ray diffraction residual stress measurements for detecting precursors to fretting-fatigue damage, especially in a laboratory setting. Several dog-bone shaped samples of Ti-6Al-4V were shot peened to three different intensities – 4, 7 and 10 Almen – with complete surface coverage in each case. X-ray diffraction was used to measure the surface residual stress prior to subjecting the samples to fretting. The samples were then subjected to fretting fatigue, after which x-ray diffraction residual stress measurements were again made. These measurements were made across the width of the scar, both parallel and perpendicular to the direction of fretting as shown in Figure 3.5.3-1. Figure 3.5.3-2 shows typical measurements results before and after fretting.

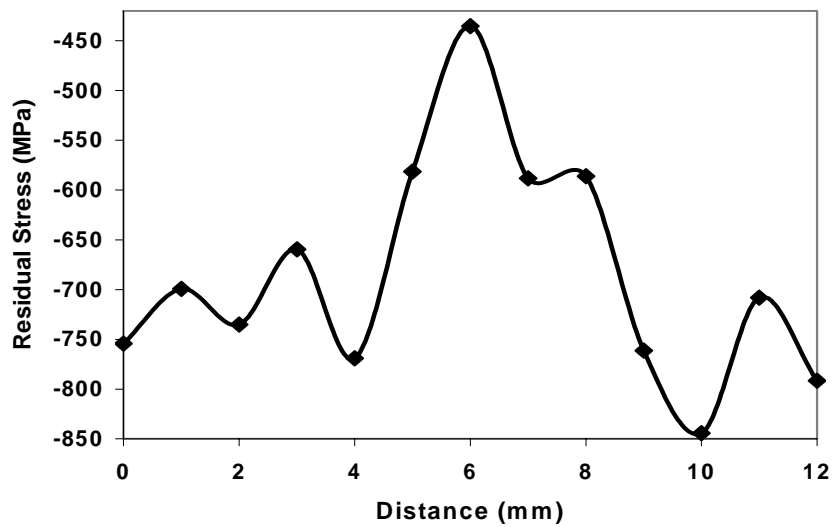
Figure 3.5.3-2. Results of x-ray diffraction measurements of residual stress across a fretting scar in shot-peened Ti-6Al-4V

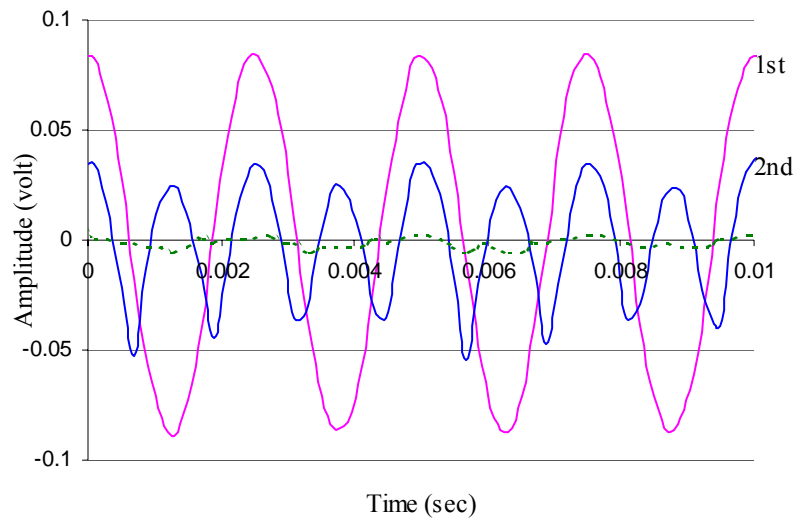
Figure 4.1.2-1. Comparison of time domain signals from the 1st (larger amplitude) and 2nd (higher frequency) harmonic mode, and background noise (in dotted curve).

mode and the period was doubled. The background level (dotted curve) was also plotted for comparison.

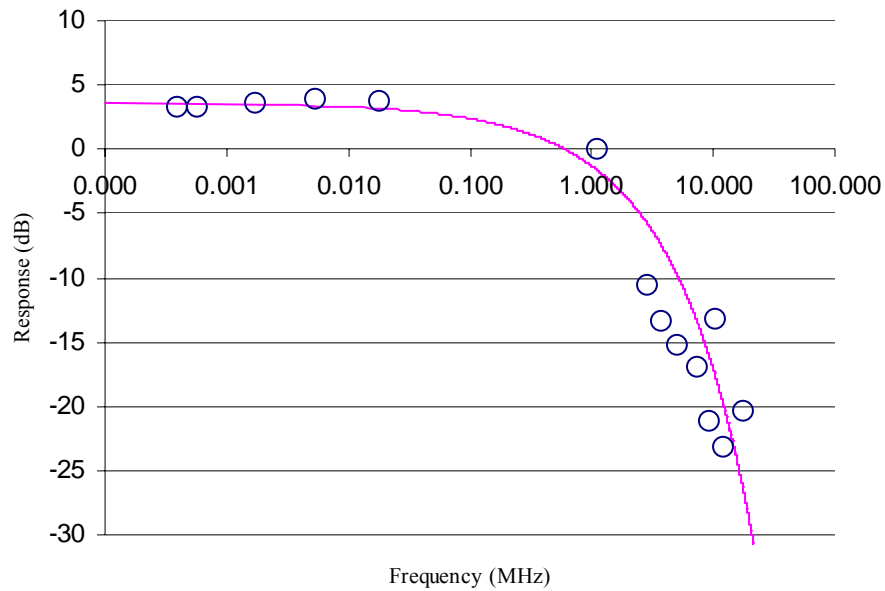
Figure 4.1.2-2. Experimental measurement of the frequency response of a GMR sensor.

A series of quantitative measurements was conducted to characterize the frequency response of a GMR sensor. Figure 4.1.2-2 shows the frequency response of a GMR sensor in an unbiased case. An exponential curve was fit to the data to better illustrate the trend. The experimental results showed that the GMR sensor has a flat response at low frequencies up to 1 MHz. For frequencies above 1 MHz, the amplitude response of the GMR sensor decreased steeply (a 20 dB drop from 1 MHz to 17 MHz). To further test the low-frequency response of the GMR sensor, a 3 mm (122-mil) thick aluminum plate, which simulates the two-layer lap joints commonly found in KC-135 and Boeing 707 aircraft, was used to determine whether or not the sensor could detect the magnetic field through the plate. The results indicated that the sensor could easily detect signals in the kHz range through the thickness of the plate. Then, to qualitatively test the sensitivity of the GMR sensor to thickness variations that would occur as a result of buried corrosion, an additional 0.75 mm (30-mil) thick aluminum plate was placed next to the 3 mm (122-mil) plate. The GMR sensor was able to distinguish the difference in thickness well.

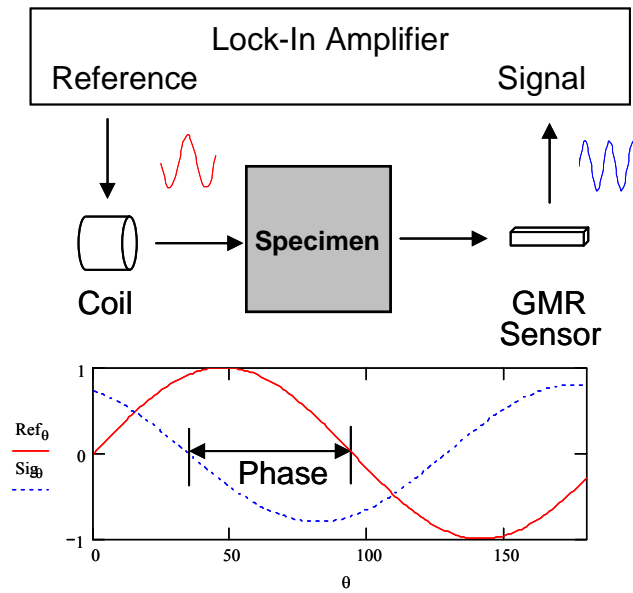
Figure 4.1.3-1. Schematic of the instrumentation together with a plot illustrating the phase difference between the reference signal and the through thickness, as-received GMR-detected eddy-current signal.

Because of its very high precision and accuracy, a lock-in amplifier was used to drive the transmitting eddy-current coil and to monitor the output from the GMR receiving sensor. This amplifier uses a technique known as phase-sensitive detection to identify the component of the signal at a specific frequency and phase. Noise signals at frequencies other than the reference frequency are rejected. Figure 4.1.3-1 shows a schematic of the instrumentation that was used for the data acquisition during development of an eddy-current corrosion metric.

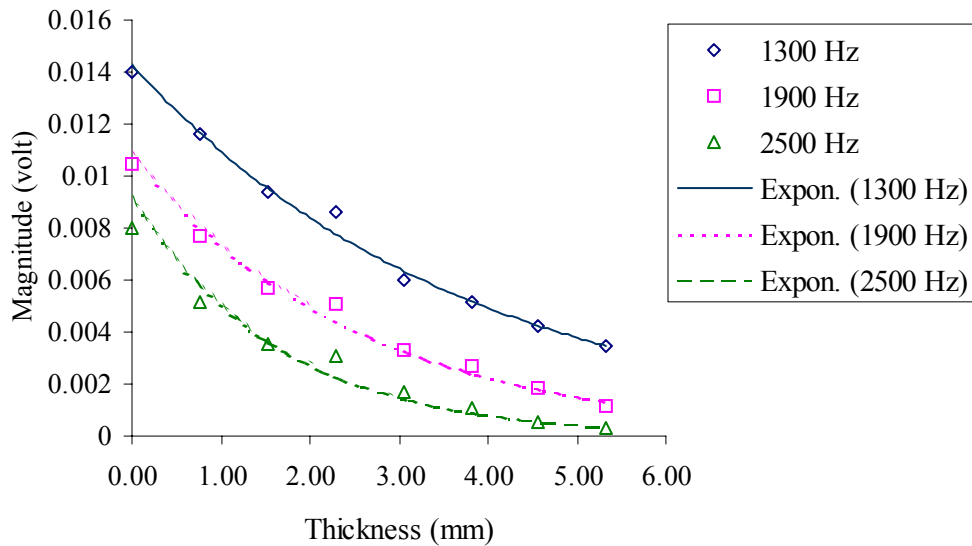
Figure 4.1.3-2. Changes in GMR signal magnitude (at three frequencies) with thickness. The sample was a multi-layered laboratory specimen.

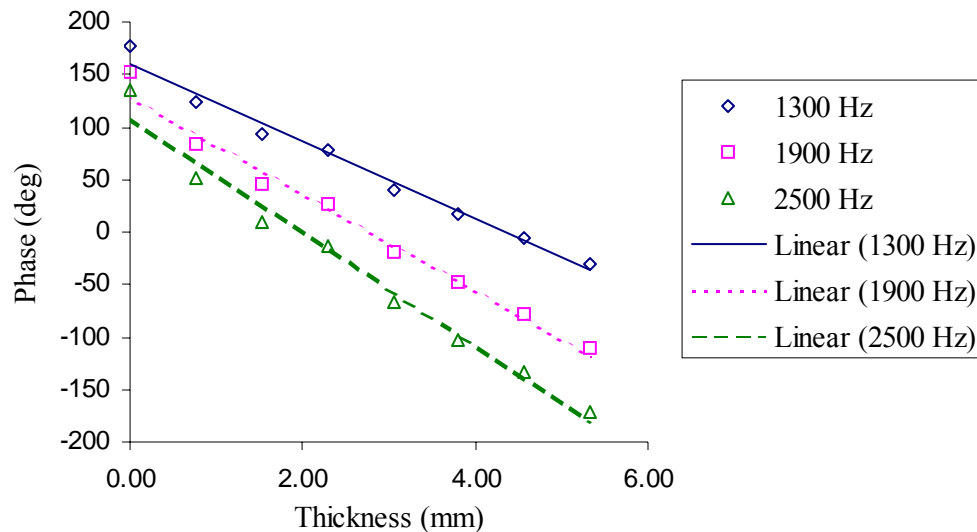
Figure 4.1.3-3. Changes in GMR signal phase (at three frequencies) with thickness. The sample was a multi-layered laboratory specimen

increased as the thickness increased. In addition, the relationship between the phase change of each signal and the thickness was linear. Thus, this phase value could be a potential metric for monitoring local thickness variations due to hidden corrosion.

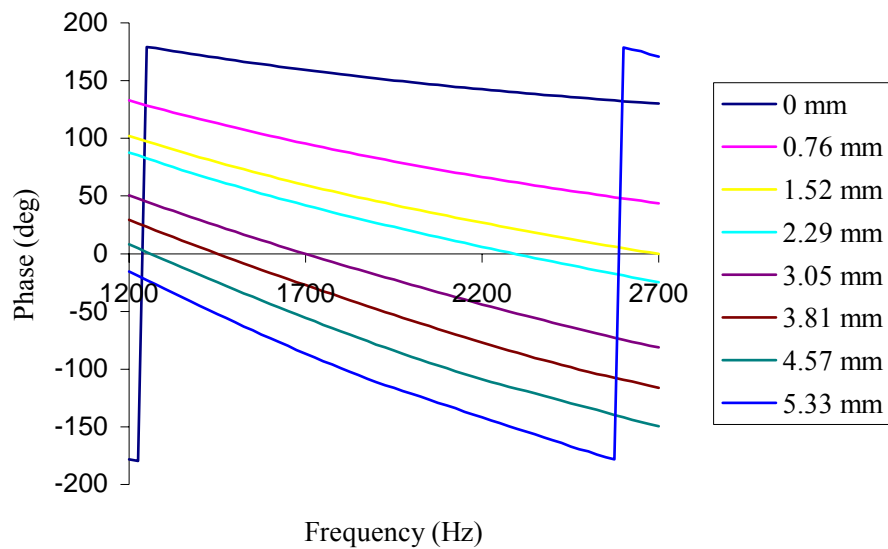
Figure 4.1.3-4. Lock-in amplifier phase output (at various thicknesses) as a function of frequency. The sample was a multi-layered laboratory specimen.

Rotating the impedance plane was chosen due to its ease of implementation. This rotation is similar to changing the reference phase angle in the more-conventional impedance plane measurements. It changes the absolute phase angle, but does not effect the change in phase as a function of material thickness. Experimental data showed that, after rotation, the phase angle does not cross one of the reversal boundaries for thickness in the range 0 to 5.3 mm (0 to 0.210 in.), at least for frequencies between 1.3 kHz and 2.5 kHz. This verifies that the phase approach – after a proper rotation of the initial phase angle – can be used as a metric to quantify local material thickness variations such as those that are caused by corrosion. Figure 4.1.3-4 shows the rotated lock-in amplifier phase from a multi-layered laboratory specimen at various frequencies.

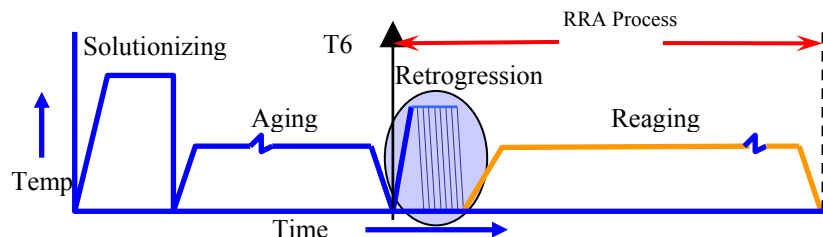
Figure 4.1.4-1. Schematic of the Retrogression and Reaging (RRA) process for AA 7075-T6: (1) Retrogressing (at 195°C for a few minutes) and (2) Reaging (at 121° C) for 24 hours.

AA 7075-T6, a widely-used aircraft material, has been found to be prone to corrosion. To maintain the high strength of the T6 temper, but gain the corrosion resistance of the T73 temper, a two-step heat-treatment process (retrogression and reaging) [32,33] is applied as shown in Figure 4.1.4-1. The timing in the retrogressing step, as highlighted in the figure, is critical to obtain the needed material qualities, so a hardness measurement is typically used to determine the material strength. Because the currently-used hardness test is destructive, the Air Force needs a nondestructive characterization method to assure that the optimal material state has been achieved.

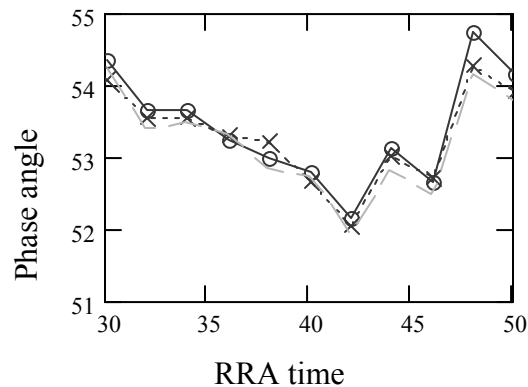
Figure 4.1.4-2. Eddy-current phase angle (degrees) as a function of heat-treatment [Retrogression and Reaging (RRA)] time.

Eleven specimens that had been solutionized and aged were subjected to retrogression (heat treatment) for durations that ranged from 30 to 50 minutes in 2-minute increments. After cooling, each specimen was subjected to four different types of measurements. Three of the measurements (electrical conductivity, eddy-current phase lag, and nonlinear acoustic parameter) were made for correlation with the fourth measurement, i.e., Vickers hardness. The electrical conductivity data (made with a commercial conductivity meter) showed only small differences (within 2% IACS) with large scatter when correlated with Vickers hardness data. Phase lag measurements made with an instrument setup as shown in Figure 4.1.3-1 (coil transmitter, GMR receiver and lock-in amplifier) provided reliable data with low scatter. The plot in Figure 4.1.4-2 shows that the phase output from the GMR receiver reached a clearly-discernable minimum at a retrogression time of 42 minutes. The nonlinear acoustic parameter shows 2 peaks when plotted as a function of retrogression time (Figure 4.1.4-3) during RRA. The first peak is between 20 and 40 minutes, whereas, the second peak is at 45 minutes. This is similar to the results obtained by Cantrell and Yost for aging of AA 2024-T4 to T6 [34-36]. Additional measurement with Vickers hardness as a function of retrogression time also shows two peaks. The first peak occurs after 20 min. and the second at 40 min. A maximum of the nonlinear acoustic parameter and a minimum of eddy current phase occur at a time of 42-45 minutes where optimized material hardness and corrosion-resistance properties have been observed.

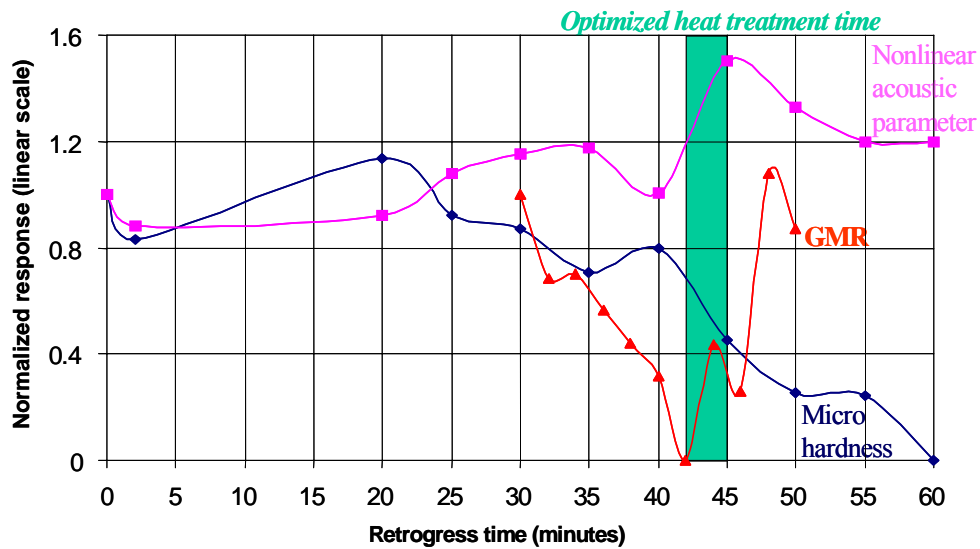
Figure 4.1.4-3. Plots showing a maximum in the nonlinear acoustic signal and a minimum in the GMR-detected eddy-current phase difference at a time of 42 to 45 minutes, at which time optimized material properties were observed.

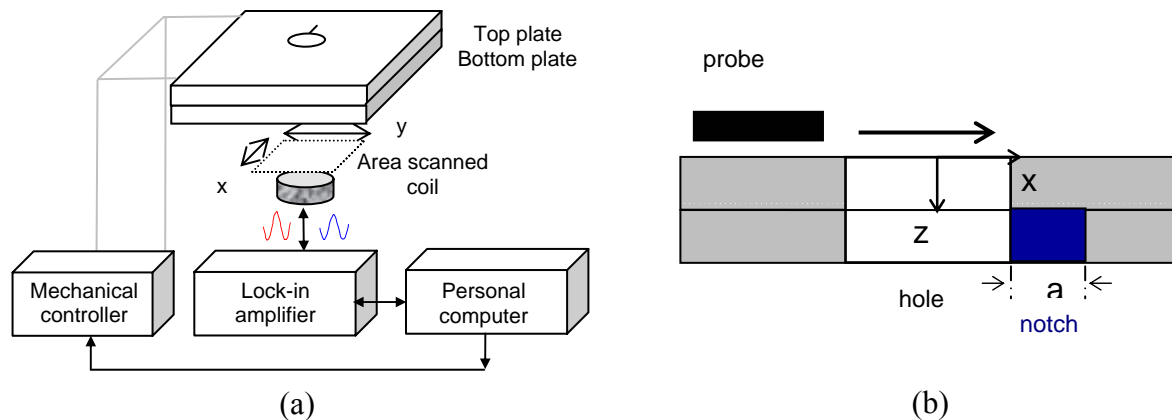
Figure 4.1.5-1. (a) A schematic view of the experimental setup showing a coil scanning of the hidden side of a through-thickness flaw in the top plate of a two-layer fastener-hole specimen, (b) Raster line scan over the flaw.

Initially, a coil was used as the transmitter and a GMR was used as the receiver to monitor the response of the signal. Experimental results using this setup showed a change of the symmetrical pattern in both magnitude and phase due to the presence of the flaw. However, it was difficult to model this experimental setup with the VIC-3D® modeling tool. Therefore, data were acquired with a different experimental setup. This second setup used a commercial coil for both transmission and reception of the eddy-current signal. The geometric dimensions of the coil and ferrite core were measured and used as inputs to the model. With this setup, a 20 mm square area was scanned using a step size of 0.5 mm and a measured liftoff of 1.0 mm. The experimental data was acquired using a lock-in amplifier that measured both the magnitude and phase of the voltage across the coil. The eddy current probe contains two bobbin coils manufactured by UniWest, but only the coil facing the specimen was used for this experiment. The amplifier excited the coil with a 5.0 kHz sinusoidal signal and the received signal was compared to the excitation signal for phase and magnitude determination.

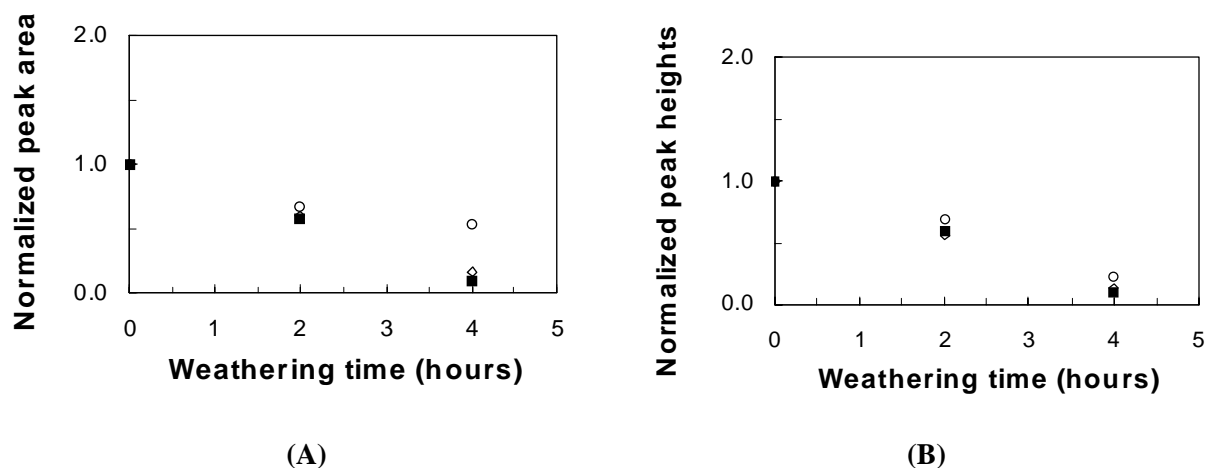
Figure 4.2.2-1: Changes in peak (a) area and (b) height as a function of weathering time for the IR absorption peak at 1509 cm^{-1} .

Measurements of IR absorption using either method rely on a good optical contact between the coating and measurement crystal. The ATR crystal is approximately $1 \times 3 \text{ cm}^2$, whereas, the diamond-shaped IR crystal is $\approx 50 \text{ }\mu\text{m}$ in diameter. The large flat contact surface for the ATR crystal results in a reduction in IR absorption for any increase in coating surface irregularity or stiffness. Therefore, higher peak amplitudes from the IR microscope indicated that the attenuation in the ATR spectra might be due in part to degradation in the optical contact between the ATR crystal and epoxy coating. Nevertheless, degradation in the optical contact between the crystal and coating surface indicates that a change in the physical and mechanical properties of the polymer surface occurred during weathering that can then be correlated with chemical property changes.

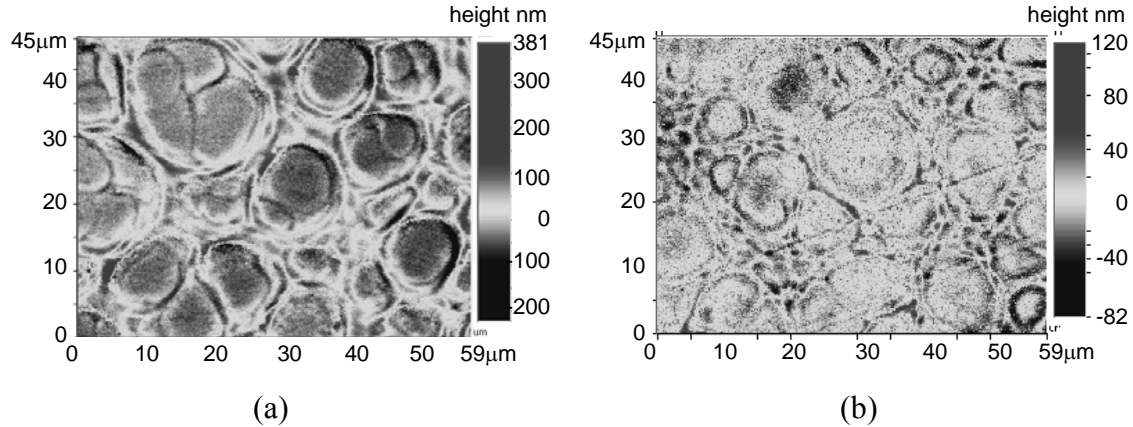
Figure 4.2.2-2. Epoxy coated panels imaged using WLIM: top surface reflection of coating (a) prior to weathering and (b) after 24 hours weathering (magnification 105.3 \times). The contrast has been enhanced in the images to clarify the topographical features.

Prior to weathering, the height variation was approximately 600 nm. In contrast, after weathering, the height variation was somewhat lower, approximately 200 nm. Details of a fine structure between the larger cells were also detected in the WLIM images. Additional images acquired using Atomic Force Microscopy (AFM) showed a similar cell pattern, but did not show the fine structure of the topography between larger cells.

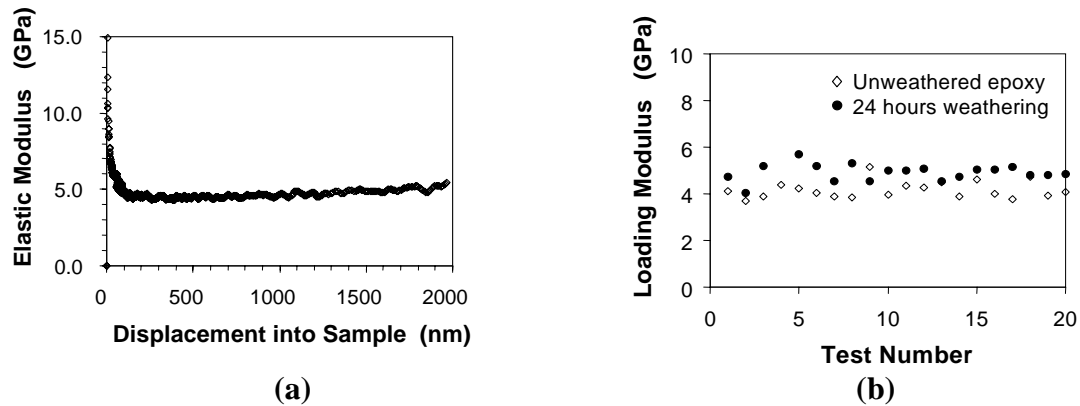
Figure 4.2.2-3. Elastic modulus measured using nanoindentation (a) as a function of penetration depth and (b) average loading modulus for unweathered coatings and after 24 hours of weathering.

may be due to differences in coating depths that were interrogated by each technique. The nanoindentation results are highly localized at the coating surface, while the SAM measurements are based on a through-thickness measurement of reflected amplitude. The differences in the results may further indicate a failure mode induced by a large gradient in the elastic properties through the thickness of the coating, thus resulting in internal stresses that ultimately lead to cracking.

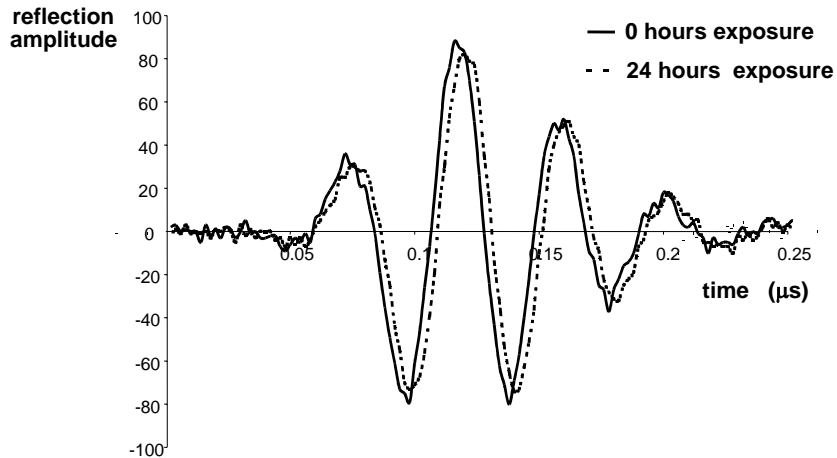
Figure 4.2.2-4. Acoustic response with and without weathering exposure. A-scans of 25 μm thick epoxy coating.

The research performed under this effort showed that the methods used were applicable for characterization of coating degradation during weathering exposures. However, to use these techniques to effectively monitor coating degradation, a complete assessment of the variability in the measurements due to normal material variability must be performed. An extensive evaluation of the variability in elastic properties using nanoindentation was initiated to determine if the changes in elastic modulus observed during weathering are within the normal variability of the panel. Similarly, correlations among the changes in surface condition and the IR absorption and acoustic properties and as-processed coating properties must be established before these techniques can be used as a robust NDE approach for monitoring degradation in polymeric protective coatings.

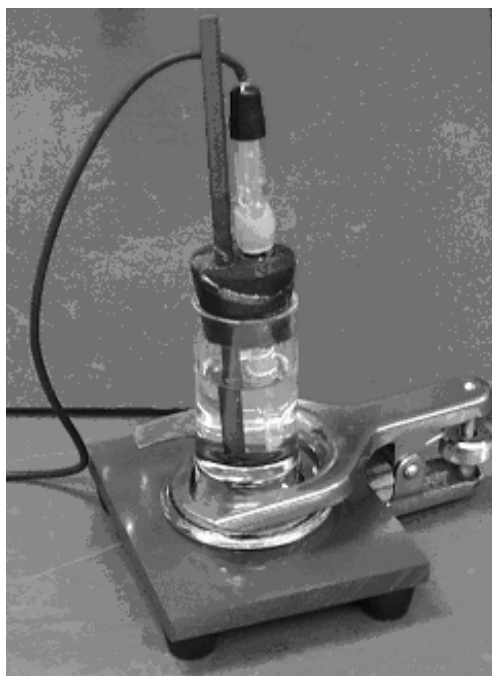
Figure 4.4.2-1. Corrosion-growth setup.

ARACOR and UDRI conducted a small study to determine the capabilities of the AFRL/MLLP branch’s Tomoscope x-ray CT system for monitoring the three-dimensional growth of intergranular corrosion. For this effort, intergranular corrosion was grown at an accelerated rate in a 6.35 mm (0.25 inch) diameter cylindrical rod of 2024 T4 aluminum. The corrosion was grown by applying a constant potential voltage to the rod that was immersed in a solution of sodium chloride, copper chloride and acetic acid. The corrosion-growth setup is shown in Figure 4.4.2-1. The specimen was corroded for a total of three corrosion-growth exposures at 48 hours per exposure. X-ray CT slice images were made at depths of 0.4 mm, 0.75 mm, 1.10 mm and 1.45 mm after each 48-hour corrosion-growth period.

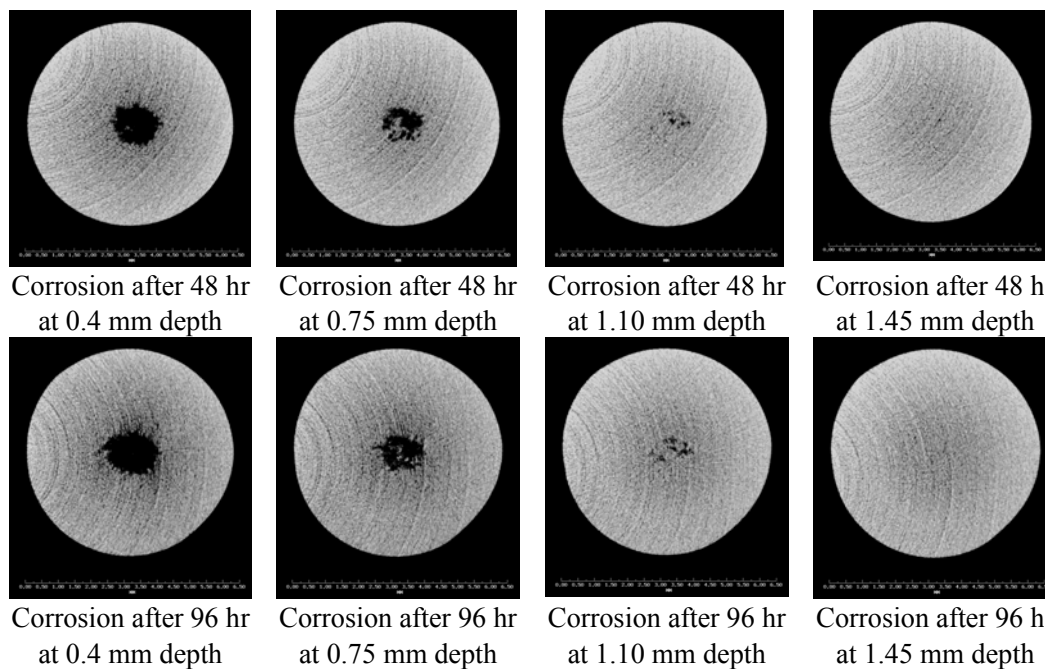
Figure 4.4.3-1. X-ray computed tomography slice images of corrosion growth at different depths in 2024 T4 aluminum.

layers and masked the existence of any corrosion at greater depths. Only the C-scan image acquired at the 0.190 mm depth indicated possible further corrosion growth.

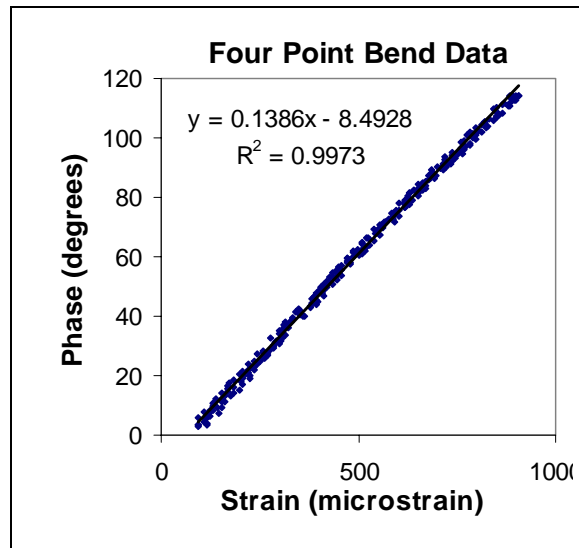
Figure 5.1.3-1. Phase vs. strain relationship.

Analysis of the four-point bend data demonstrated that a linear relationship exists between the measured phase of the surface acoustic wave and the material strain. This is shown in Figure 5.1.3-1.
